# Manhole Inspection Summary

## Manhole # S11OO1010MH

Insp Date: **6/6/07 9:50 AM**

**Location** Address: **3000 PIMLICO RD**

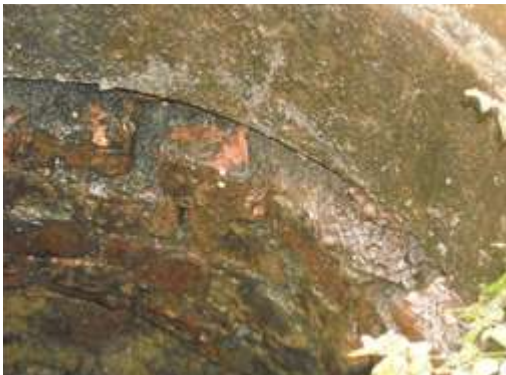
Defect 4

BRICK DETERIORATION

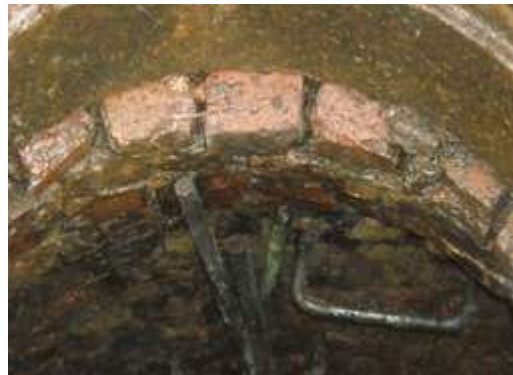
Defect 3

Condition: ☐ Sound ☐ Cracked ☐ Root Intrusion ☒ **Loose Brick** ☐ Deteriorated

LOOSE CORBEL BRICKS

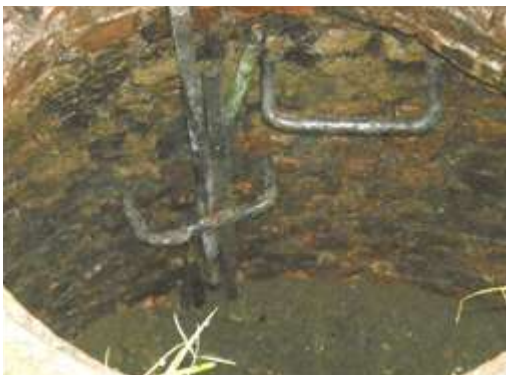
Defect 2

**Steps** Count: **2** Missing: **0** ☒ **Corroded**

CORRODED STEP

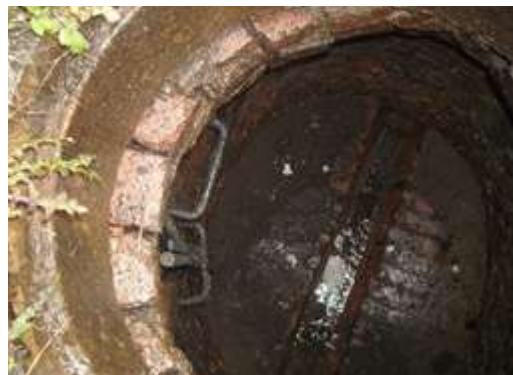
Defect 1

**Frame** Offset: **2** (in.) Condition: ☒ Sound ☐ Cracked ☐ Leaks

FRAME OFFSET

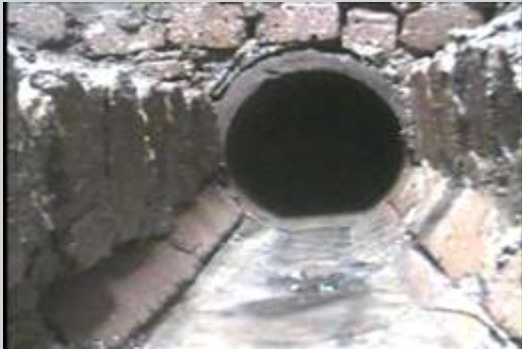
12 O'Clock Outflow

Pipe Height: **7.2** (in.) Rod and Bar (Angled)  
Pipe Material: **Clay** ☐ Pipe Lined  
Invert Depth: **5.91** (ft.) Flow Characteristics: **Slow**  
Deposits: ☒ None ☐ Mud ☐ Sludge ☐ Debris ☐ Grease  
Silt Depth: (in.) Deposits Extent:  
Infiltration: **None** Pipe Seal Cond: **Sound**

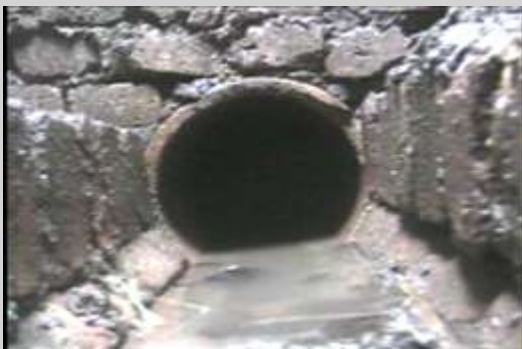
6 O'Clock Inflow

Pipe Height: **8.4** (in.) Rod and Bar (Angled)  
Pipe Material: **Clay** ☐ Pipe Lined  
Invert Depth: **5.75** (ft.) Flow Characteristics: **Slow**  
Deposits: ☒ None ☐ Mud ☐ Sludge ☐ Debris ☐ Grease  
Silt Depth: (in.) Deposits Extent:  
Infiltration: **None** Pipe Seal Cond: **Sound**
